Examining Methods of Concrete Construction in A Tadao Ando Private Art Gallery: Lincoln Park, Chicago, Illinois.

Index Terms—Chicago, private museums and galleries, Site cast concrete construction, architectural finish concrete, Tadao Ando.

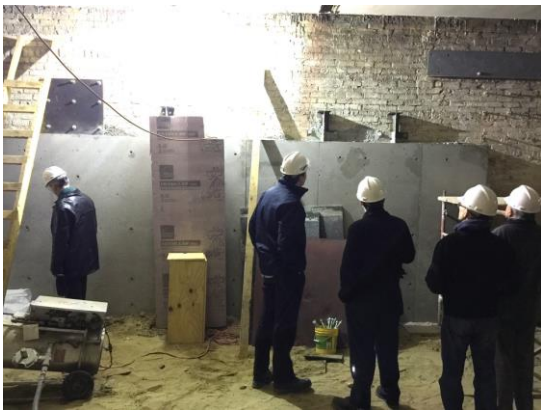
Fig. 2. Inspecting recently-unveiled basement walls.

Prior to execution of the most publicly-visible concrete elements, the general contractor, Norcon, and the concrete sub-contractor, Elliot Concrete (both of Chicago), exercised two major opportunities to practice different formwork application and bracing techniques on this job. The first of which was the casting of perimeter basement walls, which consisted of about 402 linear feet (122.53 linear m) of 9’-6” tall walls (2.9 m). These walls fortunately would never be visible to museum guests, for the basement was specifically reserved for only liquid-based mechanical systems and storage of non-valuable goods. The second opportunity for concrete casting practice was an off-site wall mock up (or full-scale construction of a variety of difficult casting conditions), which grew over time to three separate mock-up exercises in order to achieve the desired outcome quality.

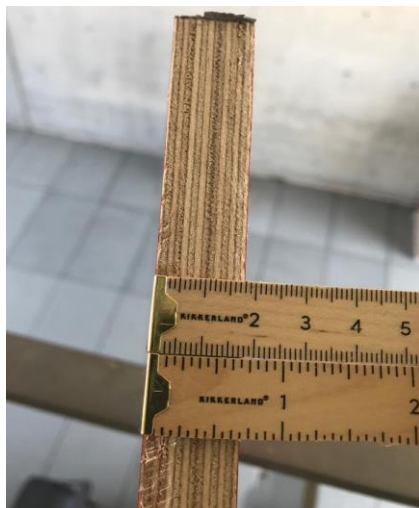
Fig. 5. FinnForm laminated plywood formwork, section detail.

The last type mentioned, FinnForm, was found to produce optimal results. FinnForm is made from 12-ply (cross-grain layered) Finnish white birch lumber, with a phenolic resin surface coating on both sides that is dyed deep red in color. It is one of the rare imported products found on this all Union Labor (Chicago and Cook County) job site. Sourced through Plywood & Door Manufacturers Corporation of Union (no relation), New Jersey.

The thickness of FinnForm panels used was 3/4"-inch thick (19 mm). It must be noted that all architecturally-exposed concrete surfaces were formed exclusively with FinnForm. However, five-story shear walls hidden in the mechanical rooms, some loading dock partial-height walls, and some fourth-floor walls which would never be seen by the public, utilized industry-common Symons gang forms (a patented product, based in Elk Grove Village, Illinois). Most Symons gang forms require no formwork ties or cone nuts and use pre-assembled smaller panels reinforced with pre-attached steel angles for rigidity and re-usability. One "window" through the finish gypsum board (attached to concrete via thin-depth hat studs) was created at the top of the fourth floor north fire exit stairwell to facilitate a framed viewport onto the surface of the two types of concrete. This opening allows one to see, side-by-side, the remarkable differences in color and finish characteristics imparted by the two types of formwork. Symons gang forms (left side of Fig. 6) are of efficient utilitarian use to quickly build a concrete wall because they are "easy to assemble, easy to strip, and reusable. The (resultant) seams in the wall are very pronounced..." [4]. Hence, they are *not* intended for showcasing any sort of concrete aesthetic, and are only visible in the above mentioned "window" and not an experience that the general visiting public would ever witness.

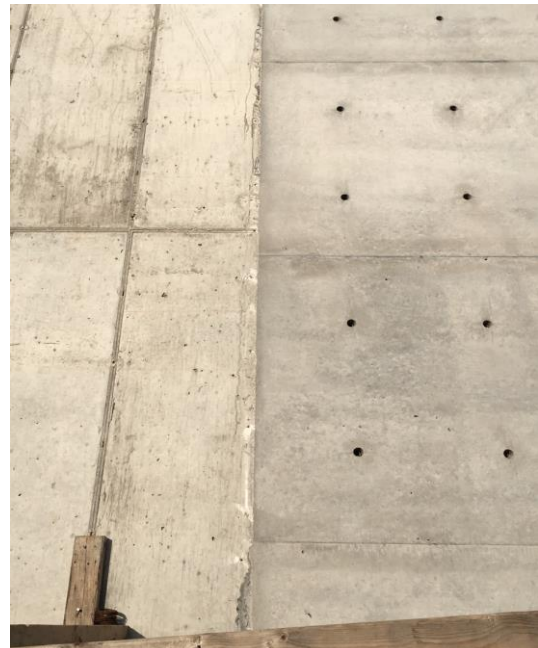
Fig. 6. Left: Symons gang form impression; Right: FinnForm face.

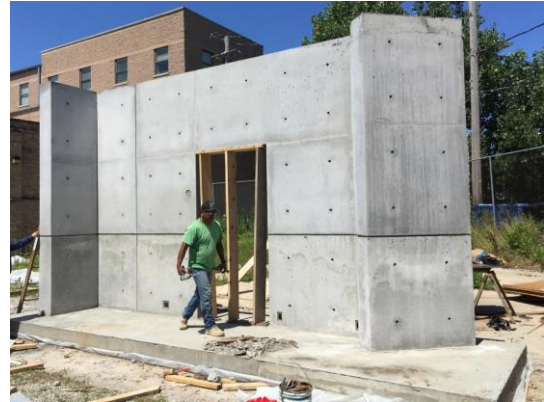
Fig. 8. Mock-up number one.

A mock-up, configured in an irregular shape of approximately 238” (604.5 cm) long x 101” (256.5 cm) deep x 144” (365.7 cm) tall, was deemed adequate to contain most all nuanced geometric formwork conditions. A suitable outdoor vacant flat at-grade site was used about 1.6 miles (2.57 km) west of the new gallery building, whereupon a flat concrete slab was first poured to provide a level “floor” surface upon which the concrete mock-up could be created.

The first mock-up utilized modified 4’x4’ (121.9 cm x 121.9 cm) and 4’x8’ (121.9 cm x 243.8 cm) large gang form panels with additional tie-holes added to attain the desired aesthetic affect. Vertical control joints, construction joints and butt joints were all included in the mock-up. A long, wide 3/4” (1.905 cm) horizontal construction joint (visible above) was also incorporated. Recessed panels for both light fixture sconces and switch / outlet face plates were part of the mock-up. Corian (a DuPont brand homogenous acrylic polymer mixed with alumina trihydrate)[6] commonly used for solid-surface kitchen countertops, was anchored to the inside faces of the formwork panels to create both construction joints as well as desired recesses for electrical devices.

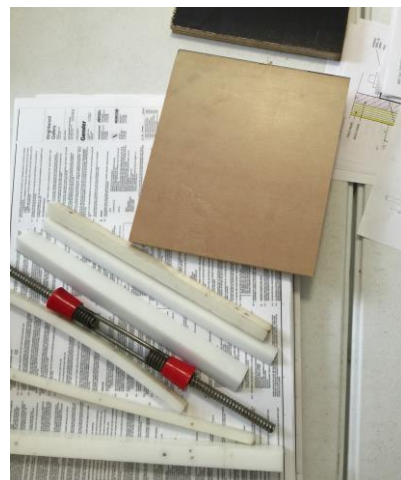
Fig. 9. Formwork samples and Corian insertions for mock-up.

Corian was chosen for its relatively superior dimensional stability, lack of absorption of most liquids including water, and easy ability for layers to be clamped and glued together (with epoxy) in the shop. Corian can also be cut and sanded

to be formed to desired sizes and shape in a mill-work shop, and has ability to be coated with formwork release agent without adverse affect upon its surface, material degradation or de-lamination.

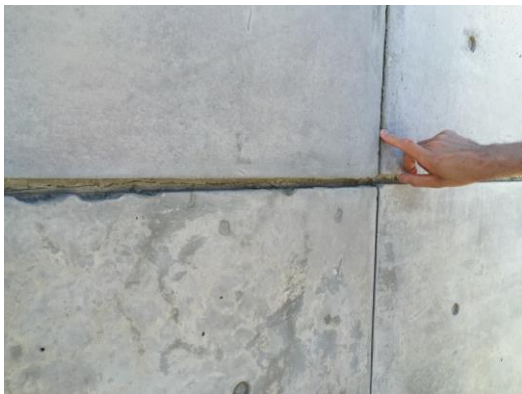
Fig. 10. Post-stripping of mock-up number 1; detail.

Upon stripping the formwork (as proscribed) on the third day after the pour, the results were immediately observed and noted. Unfortunately, the first mock-up was a relative complete failure, for the concrete displayed a full array of aesthetic (not structural) defects. For example, excessive air pockets had adhered to the surface of the formwork leaving irregular-shaped cavities or voids, commonly known in the field as “bug-holes.” Secondly, concrete had not evenly settled around large horizontal construction joints, leaving twisted-ribbon-like linear voids on the surface of the wall where concrete should have filled in. Third, lift-lines were visible near the end of the last pour. Lift-lines are vaguely horizontal or slightly tilted lines of different shade or texture that indicate where one batch of concrete (although of the same mix from the concrete plant), was deposited into the formwork at markedly different internal or ambient temperatures, yielding both excessive air pockets as well as unacceptable contrast in face color of the finished, set concrete.

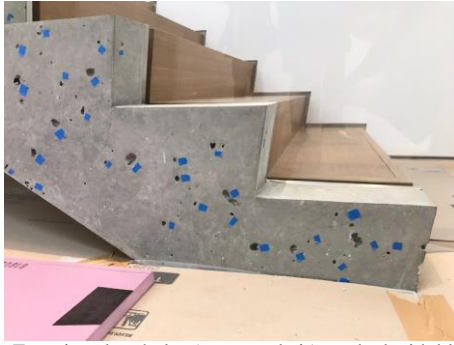
Fig. 12. Egregious bug holes (entrapped air) marked with blue tape.

The third mock-up did not encompass the same geometric form as mock-up numbers one and two. Instead, mock-up number three occurred over two and a half years later, as a problem-seeking and problem-solving exercise. This mock-up came about as a result of the discovery issues involved in the pouring of the first staircase composed of architectural concrete. Previously on the project, extensive fire exit stairs had been poured (two separate sets, from basement up to the fourth floors), but out of structural concrete (since they are not viewable by the public on a regular basis). The problem arose when a long run of internal art gallery stairs (traveling from a landing just above floor level three to level four) exhibited major pour problems upon stripping of the formwork. This particular straight-run staircase possessed an exposed concrete underside, fully exposed stringer, and with what appears to be an ornamental (non-walkable) tread and riser—all constructed out of architectural concrete. Sadly, both the exposed stair-stepped stringer and the underside exhibited excessive bug-holes of a size not before witnessed on this project (some in excess of 2” or 3.81 cm in width). A much smaller mock-up, consisting of just seven risers, was created in a construction staging area, just across the alley from the gallery building, for further

This third mock-up, created after the cast-in-place permanent straight-run staircase exhibited the large bug hole issue, was done to ensure the next large set of stairs, to be cast in the three-story atrium space (42'-1" tall or 12.8 m), would not possess similar air-entrapment issues. The solution found, made actually no modification to the formwork, nor steel rebar placement—but instead the actual mix ingredients were modified. The error which yielded excessive air bubbles or bug-holes was the improper ratio of add-mix to the concrete batch of superplasticizers, at the plant (in other words, not enough superplasticizers were added). This resulted in a more stiff mix, which the team at first desired, in order to properly pour a stepped riser/tread/stringer combination. (For if the mix had too low a viscosity, excessive hydrostatic pressure would build up in the first few steps of the staircase and potentially leak and “blow-out” the formwork, due to gravity and weight of the wet concrete). However, in this case, the mix was too stiff, not allowing entrapped air to escape from typical vibrator use. One solution remained in the idea stage and was not pursued: more vigorous vibrator use or vibration of actual formwork. In both cases, precision of the final cast concrete would be lost, and risk of damage to the formwork by unintentional vibrator contact would have resulted in a marred concrete face-finish. Hence, the amount of superplasticizer was adjusted; and the use of a hand-dipped vibrator continued with no change from previous procedural concrete casting methods.

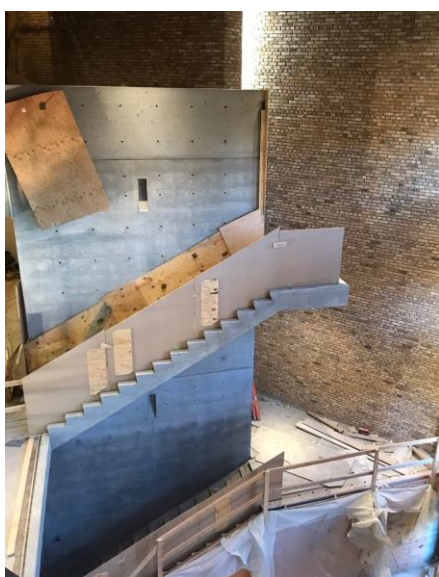
Fig. 15. Staircase cantilevered from 'fin' wall.

A giant (but thin, measuring only 12" thick, or 30.48 cm) 'fin wall' extends 35'-5" tall (10.79 m) upward, and simultaneously acts in its core as a giant column (12" x 14.5' long or 30.48 cm x 4.41 m) bearing the weight of the majority of second and third floor balconies. At its center point is situated a pile cap covering a typical set of five micropiles. This fin wall does not extend upward to touch the ceiling/floor structure of the fourth floor however (a giant welded steel box-beam spans this distance). This fin wall also supports the staircase, of which, traversing from floors 2 to 3, is fully cantilevered off of three faces of the fin wall. The staircase from levels 1 to 2 are more conventionally supported; that is, the sloping ramp that supports the stone steps is supported on both sides by spread-footing braced partial-height walls. The unitary stone tread and riser unit rests in a bed of grout and is also permanently held in place by two stainless steel pins (stone type and use is elaborated in another paper by the author).
